Case History

Hydro Power: treating the source of a problem, not just a symptom

*By S. A. Hurricks and B. A. Urquhart.
Condition Monitoring Engineers
Northern Thermal Group
Electricorp Production
New Zealand*

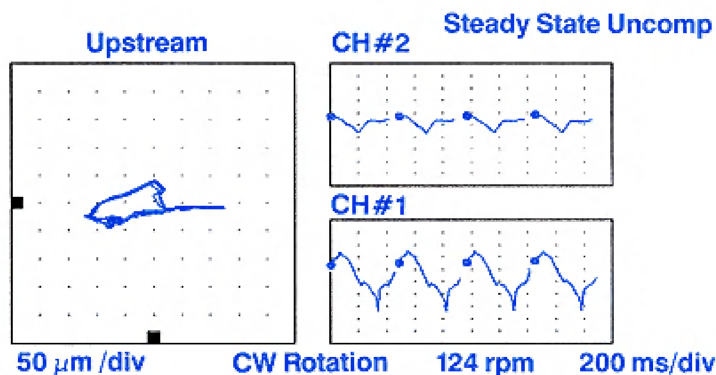
Figure 2
Orbit/Timebase plot of main guide bearing

After the machine was shut down, the data was downloaded to a portable computer so that the shaft Orbit pattern could be analyzed with the **ADRE® 3 Software**. It was evident from observing the shaft Orbit (Figure 2) that shaft contact had occurred.

The upper guide bearing on these machines is only a relatively small, steady bearing. The initial question was "Why couldn't the bearing pad be reinstalled after repair?" Obviously, the shaft had moved over while the bearing pad was removed for repair. Since this happened while the machine was stationary, it indicated that this problem was not purely dynamic.

The next question to be answered was, "Why didn't the main guide bearing restrict the shaft movement, preventing contact?" One possible hypothesis, as frightening as it might have been since the generator rotor alone weighs 100 tons, was that the whole main guide bearing assembly was not securely anchored to its foundation!

When Waipapa's maintenance personnel inspected the main guide bearing assembly, they discovered that it had worked itself loose. The large dowel pins, which locate the bearing carrier assembly, had worked themselves out, allowing the bearing assembly to move.

Consequently, the shaft radial load was transferred to the small upper guide bearing. As a result, the upper guide bearing was overloaded, causing the contact and high temperatures. The main guide bearing assembly was realigned and tightened. The machine has run with no further problems since then.
